March 2007

Successful strip-out by Brokk 90 in Australia

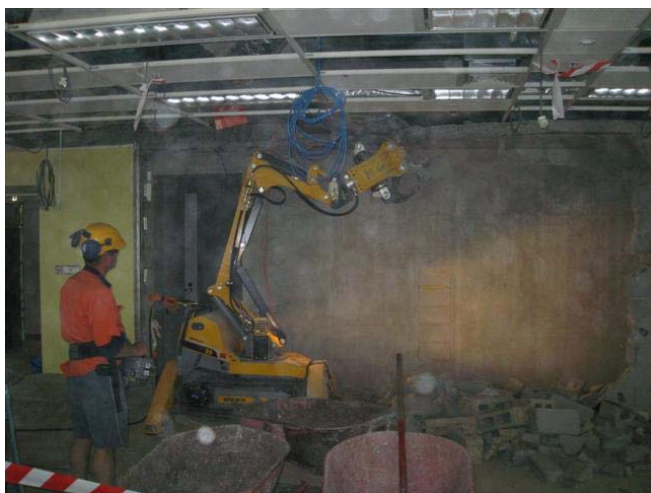
On the 44th floor existed a fire corridor constructed of block work and concrete that needed to be demolished. The corridor had been constructed only leaving at its maximum approximately 120mm gap between the top of the corridor and existing services, i.e. mechanical, plumbing, fire and electrical.

Conventional methods of removing the corridor could not be used due to occupational, health & safety, and access reasons - cutting and/or jack hammering by hand would have to be done overhead, involving a great quantity of manhours and the risk of injury.

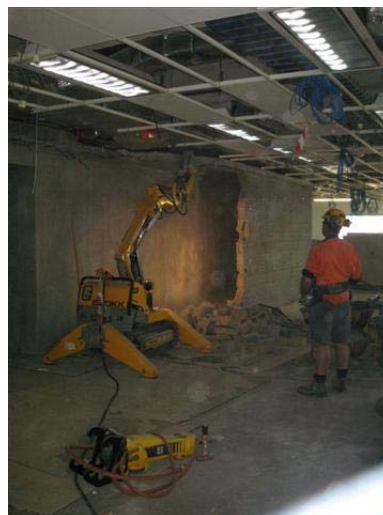
A Brokk 90 (being a 1 ton machine with a 4 metre reach) equipped with an Atlas Copco SB 150 rock breaker and Brokk CC 320 crusher was used. The crusher was used to complete 90% of the work as it is the quieter less aggressive option compared to hammering. The trimming was completed using the rock breaker to within 10 millimeters of the building core.

The Brokk was used to demolish approximately 2 metres of the corridor at a time, the rubble was then cleared away by hand into wheel barrows, which were emptied into a skip at the loading dock. This procedure maintained a clean work site and prevented excessive weight of the floor.

The size of the fire corridor was 15 metres in length, 2.5 metres in height and 1.2 metres in width. The walls were block-work and the ceiling was a 100mm concrete with light reinforced slab.
