Dismantling the Vitrification Facility at the West Valley Demonstration Project

HIGH CONTAMINATION, HIGH RADIATION LEVELS, A COMPRESSED WORK SCHEDULE, AND LIMITED IN-CELL INFRASTRUCTURE MADE THE VITRIFICATION DISMANTLEMENT PROJECT DIFFICULT. THOROUGH PLANNING, A DEDICATED TEAM, AND STRICT ATTENTION TO SAFETY AND CONTAMINATION CONTROL MADE THE PROJECT A SUCCESS.

By Michael J. Cain, Cynthia Dayton,
and Ahmad M. Al-Daouk

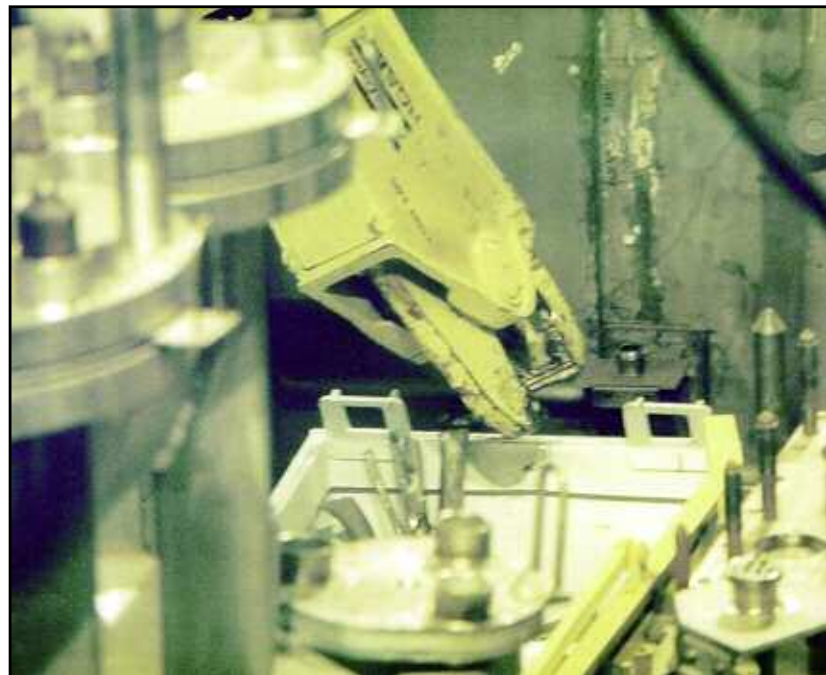
The Brokk, equipped with various end-effectors, proved useful during dismantlement of the vitrification cell.

working platform for remote radiological demolition operations. The Brokk, capable of deploying a variety of end-effector tools from a quick-connect hub, proved to be an invaluable tool in the dismantlement project. Modifications such as the installation of access doors for the electrical cabinet and hydraulic valve bank and the installation of a frame-mounted bail made prior to its deployment reduced the amount of hands-on maintenance that would be required.

End-effectors were designed for the various tasks the Brokk would perform, including a shear that proved efficient at snapping off jumpers up to 4 inches in diameter, two 800–1000-millimeter-diameter cutoff saws proficient at cutting the electrodes off the melter, and a combination cutter-gripper-spreader that is effective at picking up small debris from the floor of the cell.

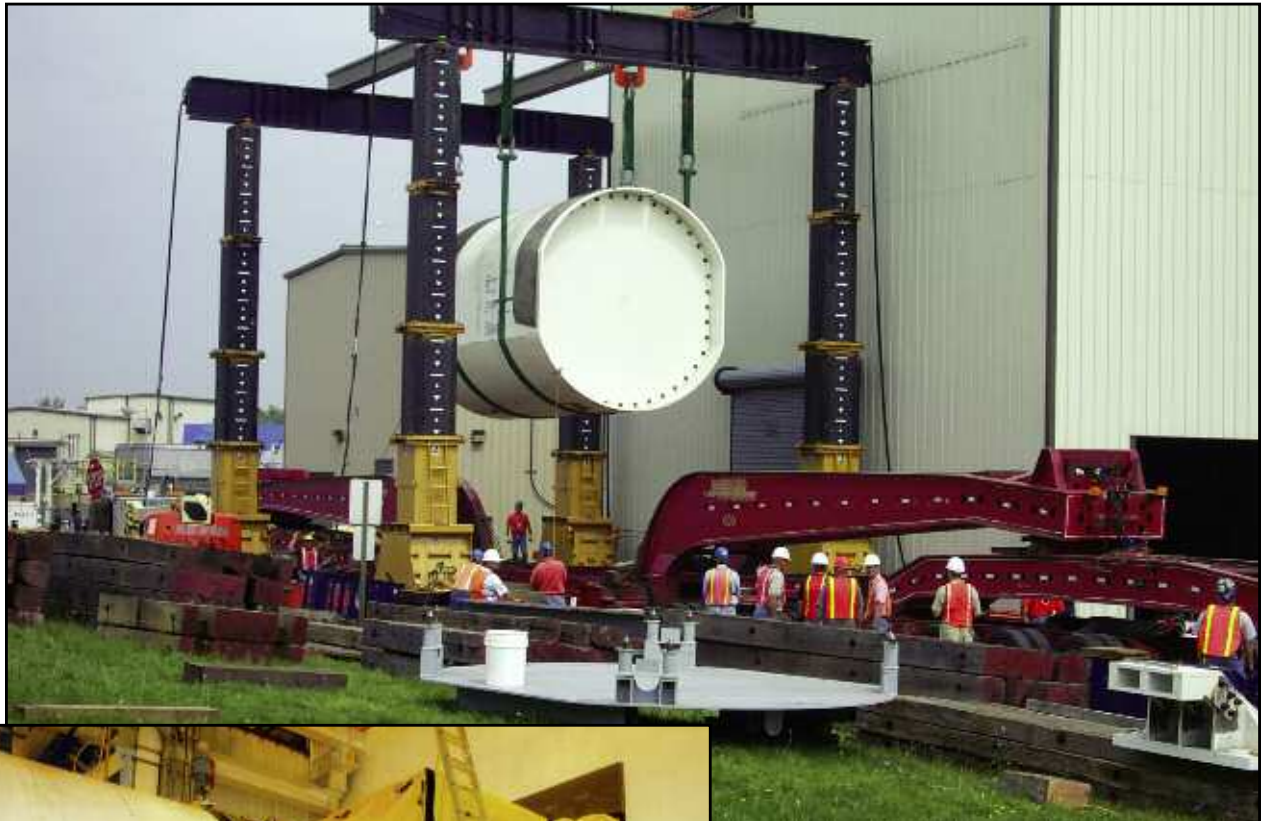
Top: The steel container constructed to hold the CFMT is unloaded from a truck upon arrival at the WVDP. It is elevated on a set of gantry cranes erected in front of the Load In/Load Out Facility to support the lifting and lowering of heavy containers removed during the dismantlement project.

Once at the site, the containers were off-loaded using a set of gantry cranes that of-

fered a smaller footprint and more stability than mobile cranes. As each container was off-loaded from the truck, it was lifted, turned, and positioned on a jack-and-slide system that transferred it across the floor of the Load In/Load Out Facility to the shield door of the EDR. Mated to the shield door with a custom containment tent structure, the container was then prepared to accept the removed vessel.

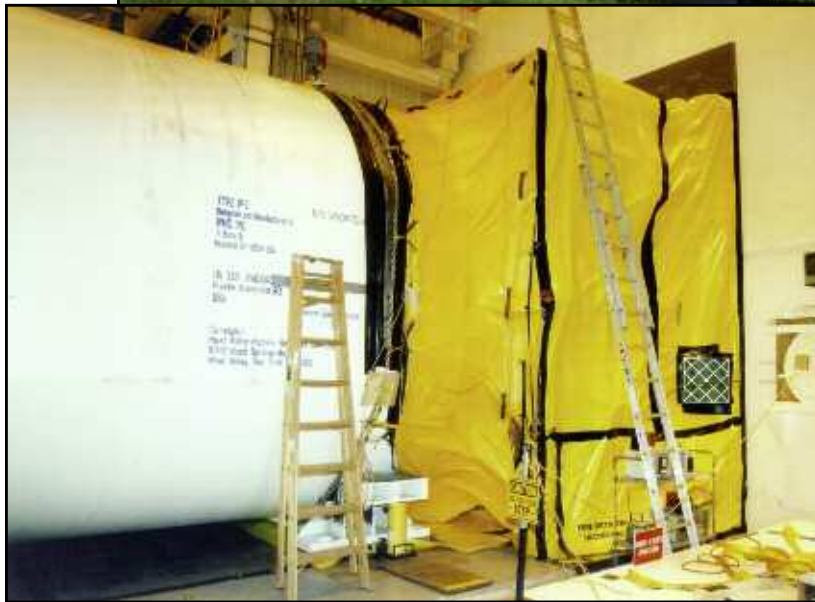
Left: The CFMT container is mated to the Equipment Decontamination Room shield door and surrounded by a containment tent to prevent the spread of contamination during vessel packaging.

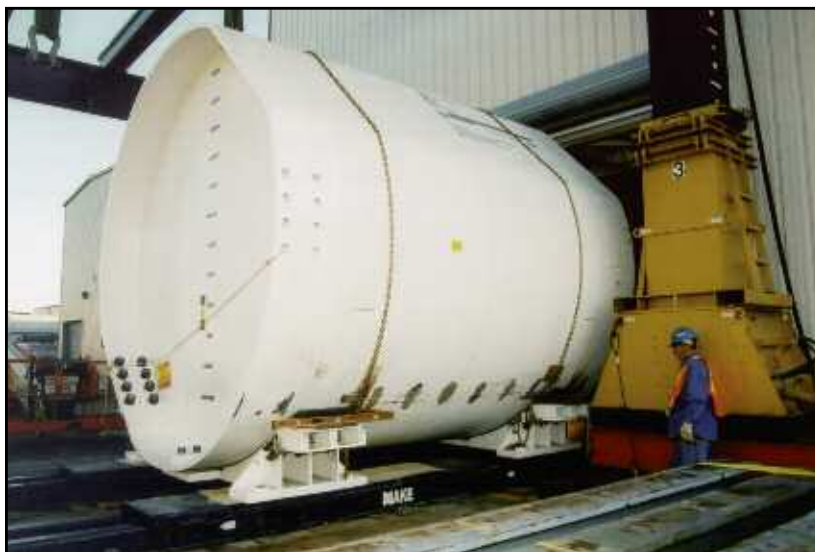
Bottom: The packaged melter feed hold tank is being removed from the Load In/Load Out Facility.

The jack-and-slide system, capable of moving the containers at approximately 3-foot increments, delivered the loaded vessels to the exterior door of the Load In/Load Out Facility. From there, the containers were hoisted in the air on the gantry cranes and positioned on a trailer for movement to an onsite storage area.

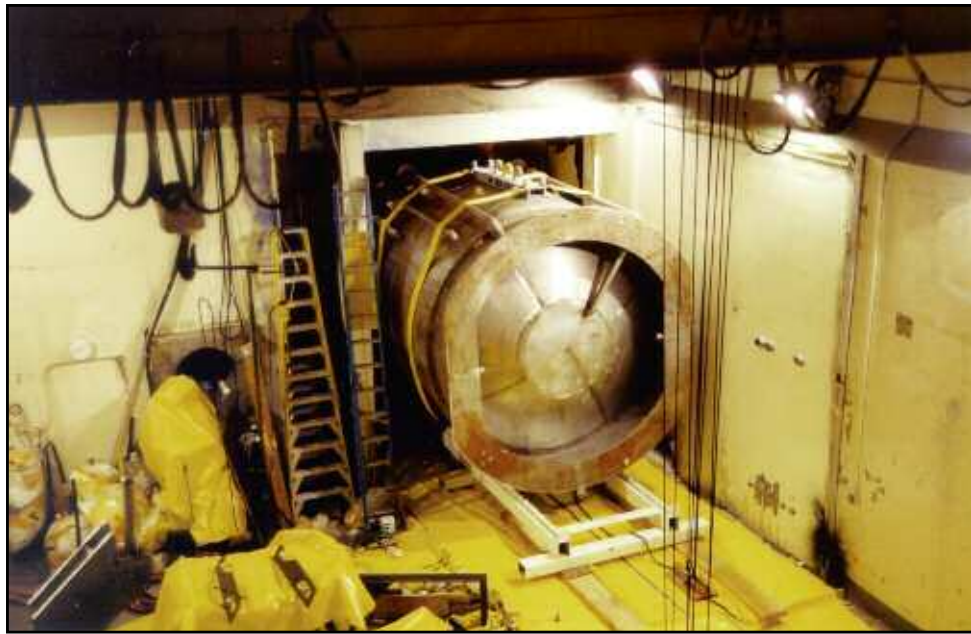
The CFMT is being drawn through the EDR shield door into the staged waste container.

Removal of CFMT and the subsequent MFHT progressed according to plan, with the vessels being equipped with belly bands for lifting inside the vitrification cell, lowered to a horizontal position near the transfer tunnel entrance, and moved into the EDR. Despite extremely confined clearances that brought the MFHT to within 0.75 in. of the transfer tunnel sides, removal of the two vessels progressed according to plan. In the EDR, the vessels were

hoisted onto a waiting cradle, drawn through the shield door containment tent, and brought to rest inside their respective containers.

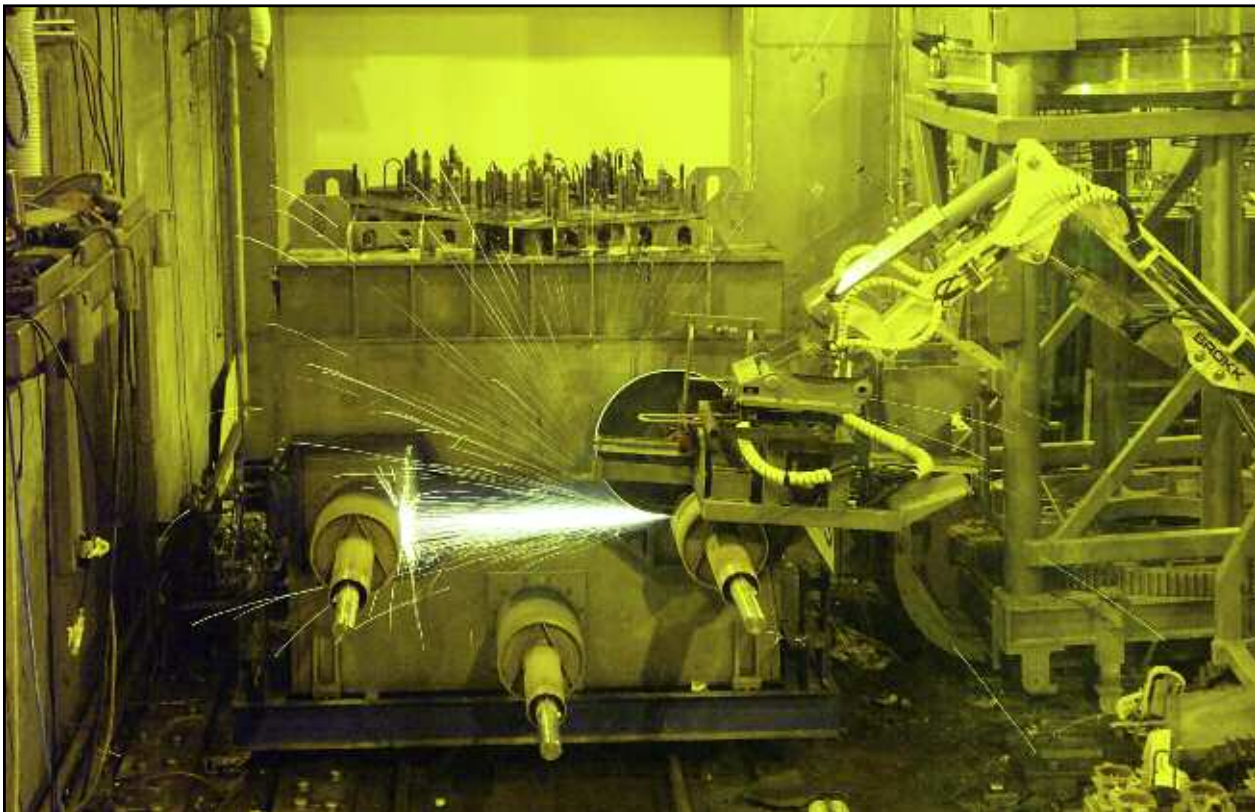
The Brokk, equipped with a circular cutoff saw, was used to cut the electrodes off the melter.

mounted 800-mm cutoff saw was then used to separate the melter electrodes from the melter, and spray fixative was applied to the vessel's exterior.

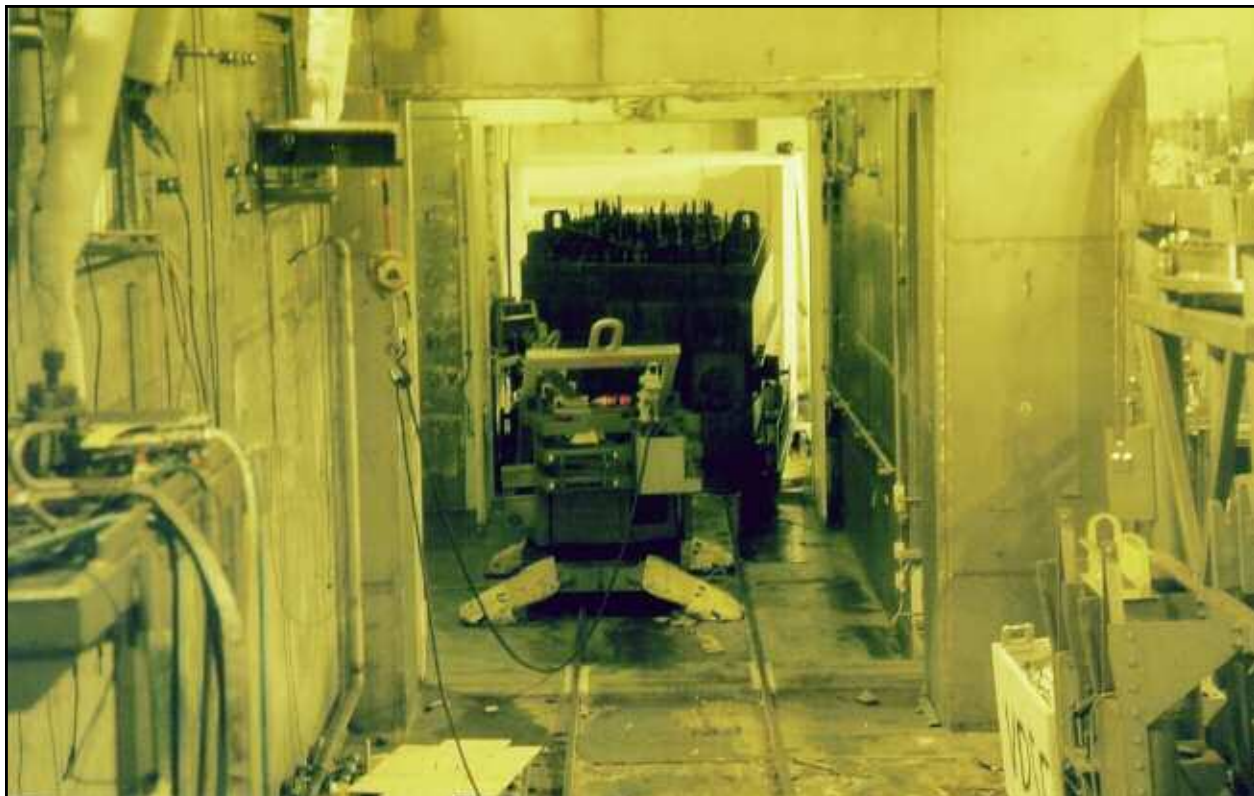
The melter encountered an interference on the tracks inside the transfer tunnel as it was being removed from the vitrification cell. The Brokk was used to position a jacking bar under the melter and return it to the tracks.

Mockup loading using a test melter was conducted at the vendor's fabrication facility to demonstrate that the vessel could successfully be moved up the inclined ramp and into the shield transfer box in the EDR. During loading of the actual melter, however, the vessel failed to travel along the inclined tracks as expected. Rail sweeps mounted in front of the rollers contacted the incline, causing the melter to lose contact with the tracks on the trailing set of rollers.

The limitations of the in-cell equipment were clearly evident at this point. With the forward progress of the melter halted a few feet inside the transfer tunnel and the back set of rollers off the track, there were few options but to devise a method to lift the vessel, slide it sideways, and reposition it on the tracks.

A number of circumstances contributed to the complexity of the melter recovery effort. The melter's location—partially inside the EDR and partially inside the transfer tunnel—made access to it limited, at best. There are no overhead cranes in the Vitrification Facility, transfer tunnel, or the EDR capable of making the melter lift. The portion of the melter requiring lifting was still inside the tunnel, where access was further impeded by a lack of clear space and limited visibility. The best available option for lifting the melter involved using a jacking bar and a 50-ton jack.

The tools needed to lift the melter were loaded into the EDR, hooked to the grapple of the overhead crane, and moved to the entrance of the tunnel. Communicating by radio, the EDR crane operator “passed off” the tools to the Brokk operator, who was working at a viewing window and display monitor nearly 60 ft from the tunnel entrance. Grasping each tool firmly in the mouth of the Brokk's shear extended over the top of the melter, a jacking bar, cribbing, a 50-ton jack, and the jack stand were all remotely moved into place on the back side of the melter.

The design efforts of vitrification dismantlement engineers, coupled with the outstanding coordination of operators outside the Vitrification Facility and within and outside the EDR, resulted in using a combination of tools and a series of incremental jacking operations to lift the melter back up to a level position. With the tools exchanged over the top of the melter inside the transfer tun-

nel and the melter repositioned on the tracks, the melter continued on its path out of the building. Thirteen days after it first encountered the rail interference, it was safely and successfully loaded into the staged container.
